DEMOLITION SAFETY-LEAD SAFETY-SILICA

When demolitions go wrong

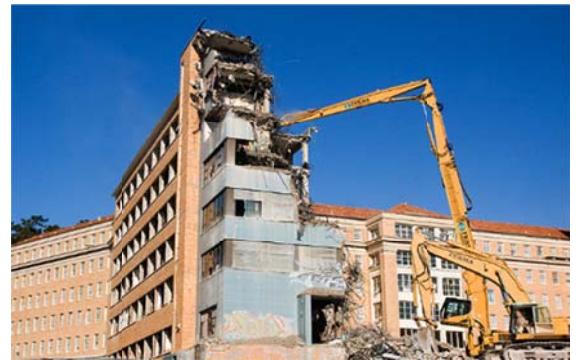
A contract to demolish high rise residential blocks built of large precast panels used a ground based high reach demolition machine. The client provided little information on the building structure to the contractor. Structural connection between panels had been poorly designed, poorly built and had deteriorated further during the life of the building. Lack of adequate information (and lack of adequate survey or assessment prior to work starting) led to a premature collapse of multiple floors across several bays during demolition works.

Fortunately, because the high reach machine was large enough, as was the exclusion zone, there were no injuries. However, the project was substantially delayed while the incident was investigated and remedial action taken. This type of building often needs panel connections to be stiffened and floors propped to a formal design prior to demolition.

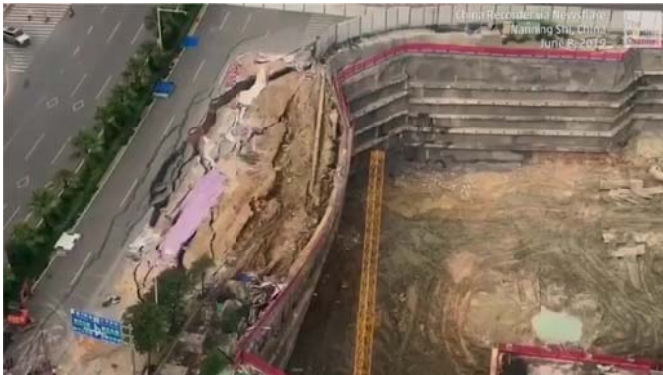
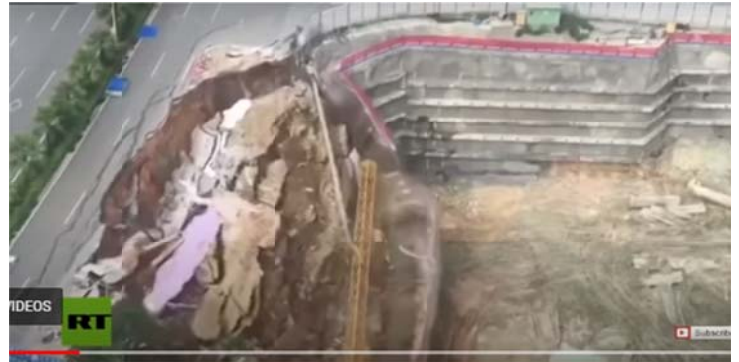
On June 8, 2019, a large part of a road suddenly collapsed into a building construction site in southern China.

Large cracks in the road appeared before the failure. Fortunately, construction officials that noticed the severe cracking, evacuated the construction site and closed the roadway. Therefore, there were no casualties. The ground beneath the road collapsed carrying away the concrete diaphragm wall that was constructed to support the soil. The causes of the failure are under investigation but rainfalls that struck the area some days before may have contributed to the collapse.

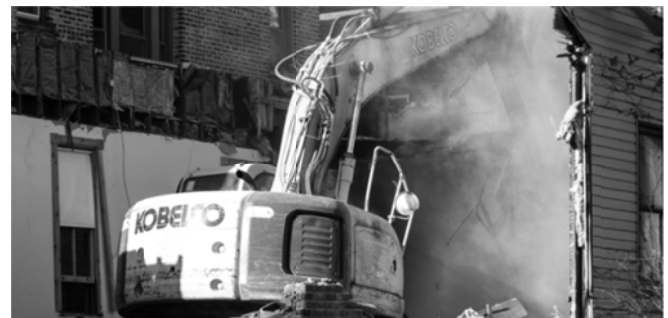
ST. LOUIS — The city issued a fine Friday to Illinois construction company GreenTrac after the building division found the company wasn't using a required dust control technique on a demolition site to prevent the spread of lead and other toxins.

The demolition crew started Thursday at 1415 Dodier Street in the Old North neighborhood without spraying water to reduce dust.

Spraying water on demolition sites can help prevent the spread of lead particles from old paint and building materials, which can enter homes and settle into backyards where people can ingest it. A 2002 study in St. Louis by the U.S. Centers for Disease Control and Prevention found a link between proximity to demolition sites and lead poisoning in children.

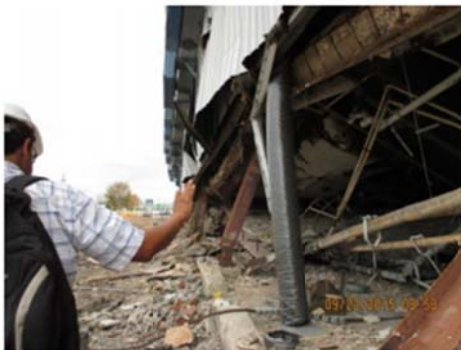
Partial west view
FIGURE 13

On September 9, 2015 at Newark Liberty International Airport, Newark, NJ, around 1:25 p.m. aircraft hangar no. 14, undergoing demolition, unexpectedly collapsed, injuring four employees. The demolition workers were on the first floor (ground floor) and the second floor of the hangar when the hangar building collapsed. Four employees were transported to the hospital with nonlife threatening injuries. One employee was kept overnight in the hospital for evaluation of his head injuries.

1. The demolition contractor failed to follow the instructions of May 20, 2015 prepared by his engineering consultant.
2. The contractor made numerous horizontal V cuts on columns above the first floor, contrary to the consultant's instructions. These additional cuts in the columns compromised the stability of the structure and significantly contributed to the collapse.
3. The general contractor failed to notice and question the numerous cuts in columns made by the demolition contractor in violation of the instructions of the consultant retained by the demolition contractor. These cuts were in plain view of the general contractor.
4. The Port Authority of New York and New Jersey had an incomplete set of original drawings.

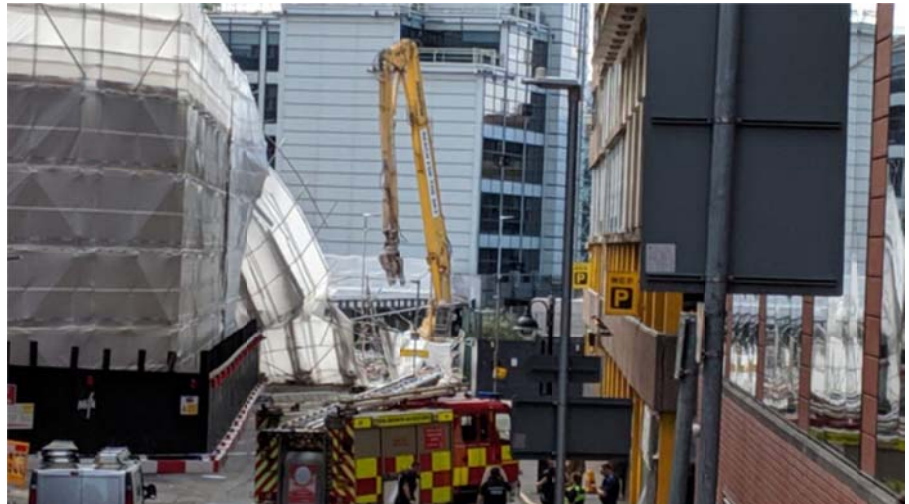
A large sheeted scaffold screen incorporating access platforms was designed and erected to encase a building. The sheeting prevented dust and debris falling into surrounding public areas while the building was demolished floor by floor by small excavators. The scaffold was supposed to be dismantled progressively as each floor was demolished. It was not. The wind got up and the sail effect overloaded ties into the remains of the building. These failed and the scaffold collapsed onto a roadway below. The Fire Department arrived and were able to evacuate the area so there were no casualties. Demolition work should have been halted at the right stage until the scaffold contractor had attended to reduce the height of the scaffold.

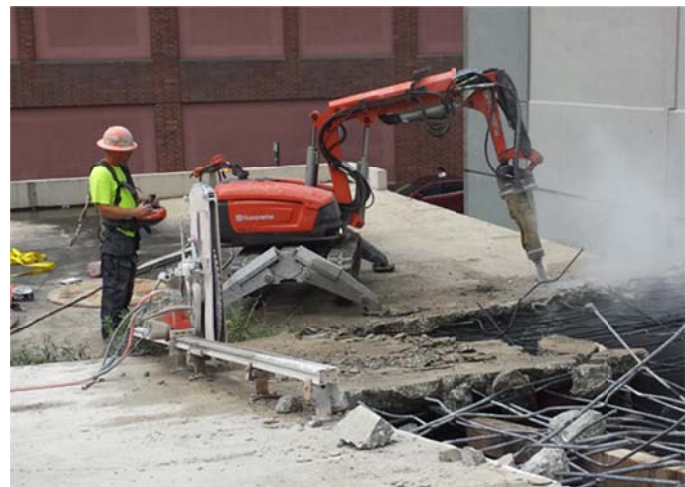
Electrician John Walker was working next to some remote controlled demolition machines on a site in Elephant and Castle in New York in August 2017 when one of the machines broke through a structural beam. This dislodged several concrete joists which then fell and struck him.

The district attorney said principal contractor, 777 Demolition and Haulage Co Ltd, and its subcontractor and sister firm, 777 Environmental Ltd, failed to properly plan, manage and monitor the demolition of the structure, which led to the collapse of the joists.

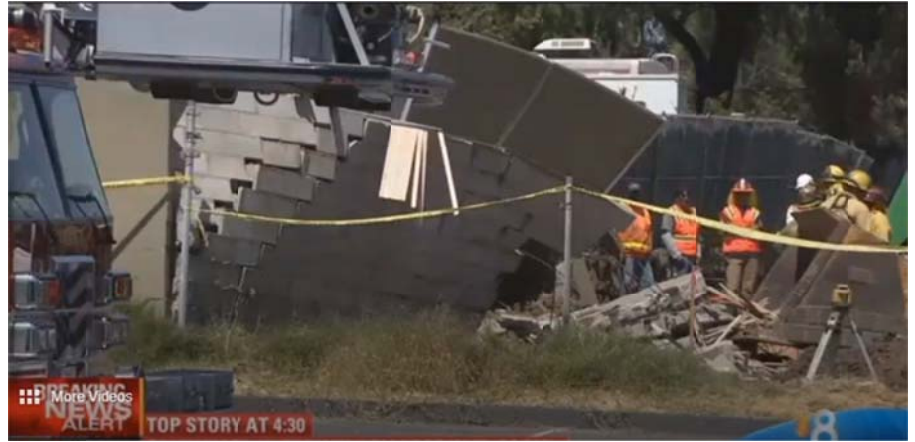
Fernando Martinez was taking a lunch break in a trench at the site of a planned car dealership at Wagner Road and North Marshall Avenue in El Cajon shortly before 12:30 p.m. Monday when a concrete-block wall at the edge of an adjacent residential yard fell on him, according to the county Medical Examiner's Office.

The contractor is being investigated by Cal-OSHA for failure to properly support the wall being demolished and for not creating a safety zone for unauthorized entry. Later the

contractor was cited for failure to conduct an engineering survey to determine the condition of the structure prior to demolition.
